## Jones combines consulting and reconstruction services to benefit of many

## Historic Church Fire

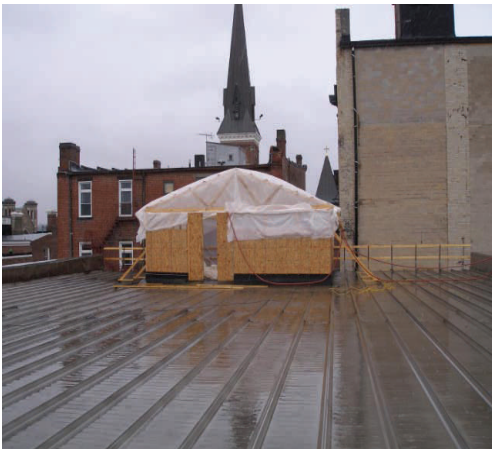
A large masonry chimney, located on a building behind the ninth unit, was blown over by high winds. The chimney fell and impacted the roof of the five story structure. There was exten-

Temporary enclosure over damaged roof

sive damage to the flat metal roof. Significant structural damage occurred to the fifth level concrete floor system, the rear masonry wall, and a concrete support beam. This five story concrete and masonry building is occupied by offices of the community development organization and provides residential housing for displaced residents and persons in need of housing.

The repair process began with the removal of well over one ton of bricks and metal roofing in order to inspect the underlying damaged concrete deck. Inspection of the deck was completed in the presence of a Structural Engineer. As a result, G.S. Jones recommended restoring the building to its condition prior to the collapse utilizing the same design as when the building was built. This would be the most economical, timely and structurally sound method. And as a result did not result in any design or architect fees.

The project was completed during the winter months. Therefore a temporary shelter was built over top of the work area on the roof so that repairs could be made without the threat of water penetration into the occupied building. Also, due to the height of the building, an elaborate scaffolding system was erected at the rear of the building. Close proximity to overhead electrical wiring posed danger to the crane and craftsmen therefore, Allegheny Power was instructed to install temporary wire covers to protect all workers. The project wrapped up on budget and on time. The Community development organization did not suffer any down time in providing their services to the residents of Westmoreland County.

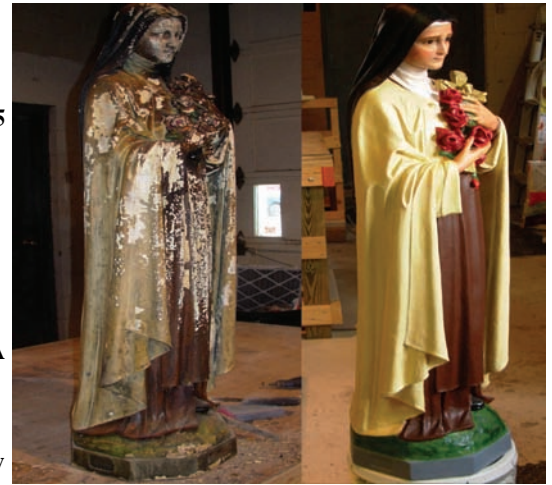
Restoration of damaged statue

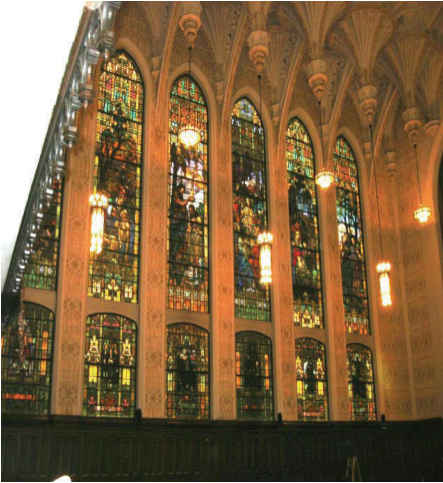
*Intricate stained glass windows*

A specialist was consulted on cleaning the antique stained glass windows. The windows could not have any cleaning solutions on them during the cleaning process or they would be permanently damaged. Windows were meticulously cleaned by hand to restore to their original state.

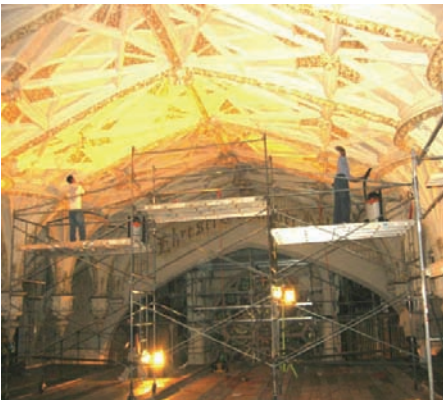
*Rolling scaffold to reach domed 56 ft ceiling*

The next step was to clean the church ceiling and upper walls that were approximately 56 feet high. Scaffolding was erected throughout the sanctuary in order to clean the entire ceil-

ing, walls and windows in the altar area, seating area and balcony. The scaffold was set at approximately 40 feet with rolling scaffold on top in order to reach the ceiling. The aisles where the braces were set were kept open to allow church members to pass to their pews.

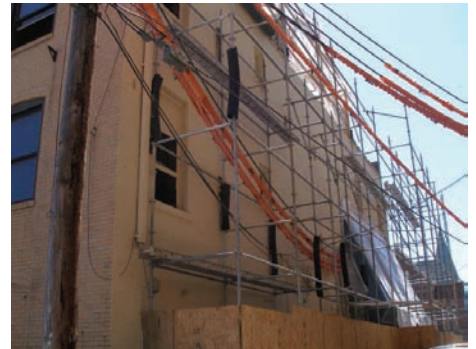
*Scaffold system around high voltage lines.*
