Rebuilding with Confidence

G. S. Jones
Reconstruction • Consulting

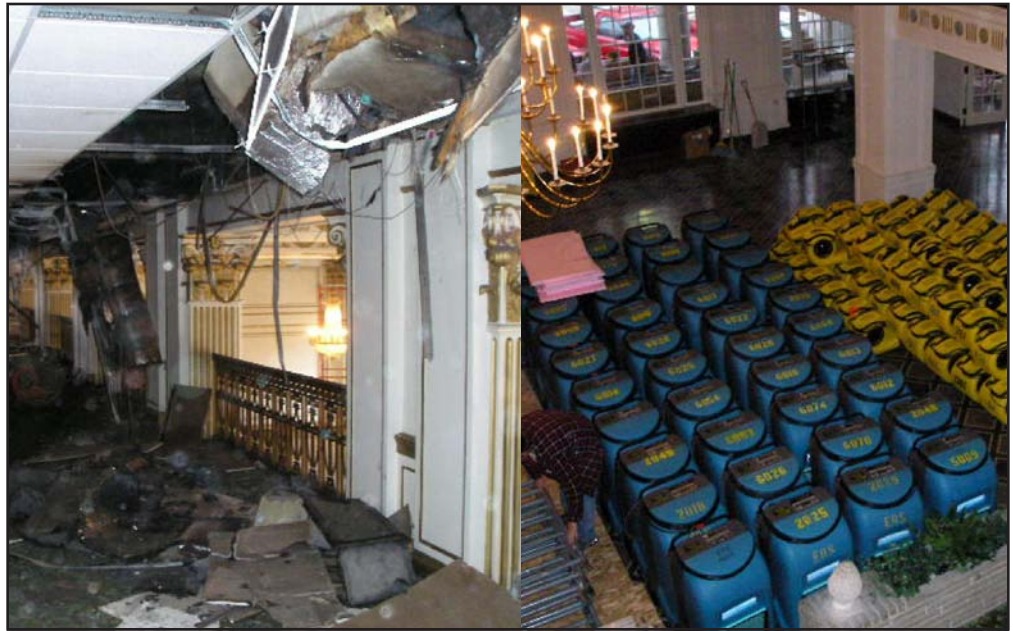
Historic Hotel Fire

On October 15, 2006, fire struck a historical hotel in Washington County. The ten story building was used as apartments, offices and an assisted living facility. The hotel also had three ballrooms, a lounge/bar, and a restaurant open to outside traffic.

Three residents were treated for smoke inhalation and a city police officer was seriously injured when he fell from a seventh floor window trying to get out of the smoked filled Hotel. The fire displaced 89 people living in the hotel, including 36 residents from an assisted living facility. The fire occurred in the area of mechanical equipment on the second floor flat roof.

G.S. Jones immediately responded with a team, following a call from the building owner to handle emergencies and to assess damages. There was heavy fire damage to the second, third and fourth floors. Heavy smoke damage was on all ten floors. The main ballroom sustained water, smoke and fire damage.

A plan of action was set and the G.S. Jones team immediately began their work. Windows were boarded up and a temporary roof was

installed to cover gaping holes left by the fire. The third and fourth floor was totally gutted. A trash chute was installed from these floors to remove debris from each room. All duct work was cleaned of soot and debris throughout the hotel.

The use of 100 air movers and 40 dehumidifiers helped to dry out the building. By staffing the hotel with approximately 70 to 135 workers, daily, G.S. Jones was able to provide emergency services as well as restoration in a narrow time frame. This resulted in great savings for the insurance company and customer satisfaction.

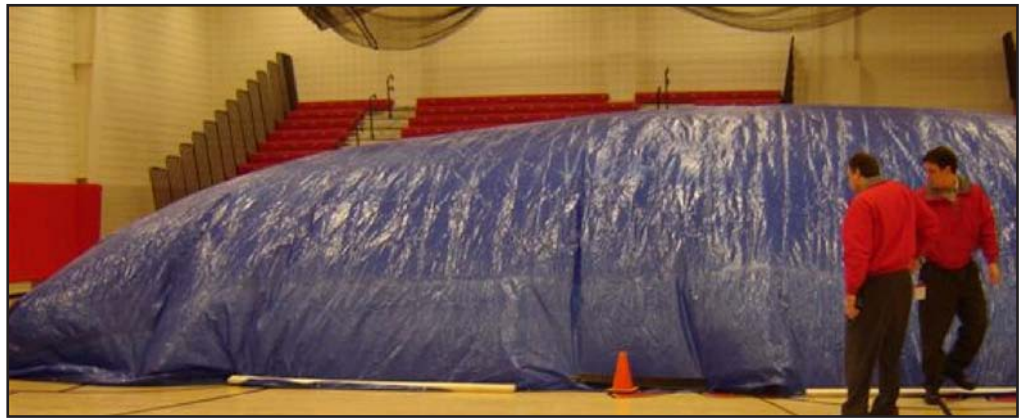
Gymnasium Floor Saved

G.S. Jones received a call from an Insurance broker to assist a local high school. During gym class a ball hit a sprinkler head, causing it to break. Before the water could be shutoff, water had saturated the wood gym floor and a wood shop class below the gym.

The first priority was to mitigate damage to the gym floor. The proper assessment of damage was crucial. An infrared camera was utilized to determine that water had become trapped between the gym floor and concrete slab, and had spread to ¾'s of the area under the wood flooring.

Being that there was space between the concrete and flooring, the G.S. Jones team opted to dry the gym floor, rather than replacing the entire floor.

Turbo dryers were placed at opposite sides of the gym where floor boards had been removed. The dryers forced air flow between the concrete and floor boards. A tent was constructed over 75% of the floor where water was trapped beneath the flooring and dehumidifiers were placed inside. Turbo dryers were used to create the "floating" effect of the tarp. All water would be extracted through the dehumidifiers.
