Is “Ghosting” In Your House a Physical or Supernatural Phenomenon?

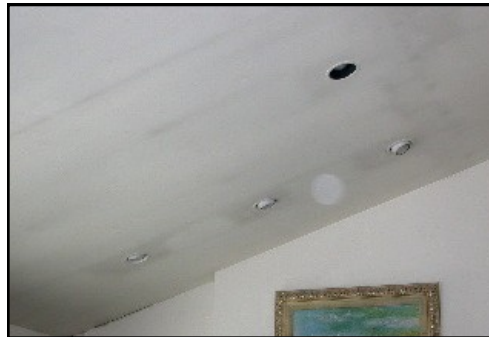
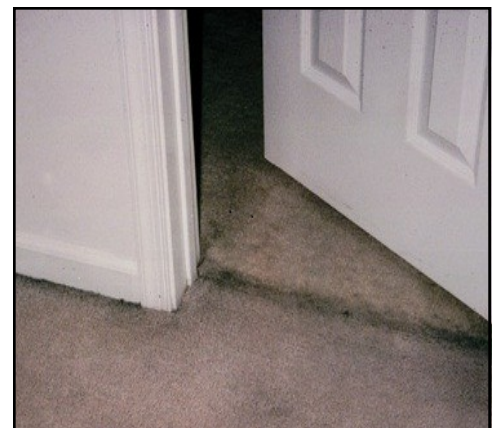
It is possible that dark stains in a home can be related to moisture problems on surfaces that may result in mold or mildew but unless signs of moisture damage are present also it is most likely that it is not mold related. Instead, dark stains that outline wood framing or dry-wall nail heads are commonly referred to as ghost stains because they can make a wall appear to be transparent.

Actually, the answer to the question is that it's a little of both physical and phenomenon. Most ghost stains are the result of small dirt, dust or soot particles that deposit on surfaces through a number of sources. Common sources include candles, oil lamps, gas fireplaces, gas pilot lights, smoking, cooking, vacuum cleaners and generally any dust producing activities in a home.

The particles mentioned are generally small enough to be in suspension in the air until they are either filtered out of the air or are deposited on various surfaces either through settlement, impaction or charged attraction. Smoke and soot particles in particular are positively charged and are naturally attracted to metal objects and colder surfaces. Therefore when there is an excessive amount of these particles in a house they will collect on the wall surfaces where metal fasteners are located or where there is air infiltration such as in corners or around light fixtures or openings in the wall or ceiling surfaces.

So what can a homeowner do? The best start is understanding the sources of the soot and dirt and the processes by which they can deposit on surfaces in the home. Eliminate the obvious and maintain appliances that produce combustion. Particularly bad stain problems indicate an air imbalance in the house and could be evaluated by a consultant specializing in home performance.

Removing the stains is not easy since they are carbon based and will smear when wiped but cleaning with a detergent and a new coat of paint or two should do the trick.
